**Flood Control Project Maintenance  
Levee Inspections**

**Fall 2014 Levee Maintenance Deficiency Summary Report**

**Sacramento River Basin**

**Sutter Maintenance Yard Maintenance Area 0007**

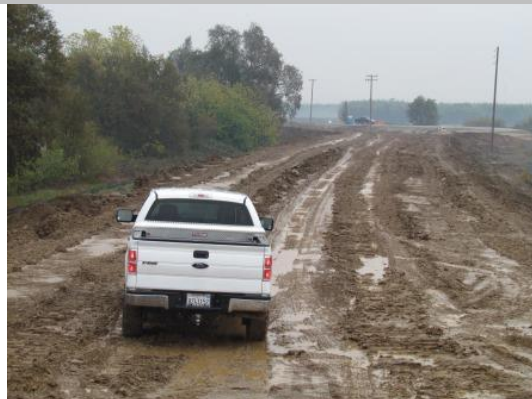
Photo 1 of 1 : FA\_2014\_MA0007\_200\_46\_20141124\_00015.jpg

LM Start	0.00	Rating **	A/W	Issue No.	46
LM End	8.07	Issue Type +	En	Location *	CR
Category	Earthen Levee			GPS Latitude/Longitude	
				Start	End
Item	Encroachments				°
					°
DWR ID	DWR_MA0007_01_f_2014_46				
Action/Comments					
Material

This photo was taken from the crown facing south looking at the levee currently under construction and unable to be inspected. Fall 2014.

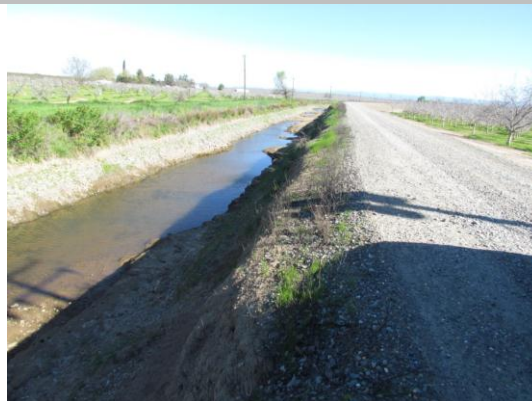
Photo 1 of 2 : FA\_2014\_MA0007\_200\_42\_20141110\_00007.jpg

LM Start	0.01	Rating **	M	Issue No.	42
LM End	1.73	Issue Type +	En	Location *	LS
Category	Earthen Levee			GPS Latitude/Longitude	
				Start	End
Item	Encroachments			39.311297 °	39.334365 °
				-121.637490 °	-121.633975 °
DWR ID	DWR_MA0007_01_s_2012_42				
Action/Comments					
Ditch Inspector Comments: Erosion along landward levee slope due to agricultural ditch.

This photo was taken from the levee crown facing north looking at the erosion along the landward levee slope due to an agricultural ditch. Spring 2014.

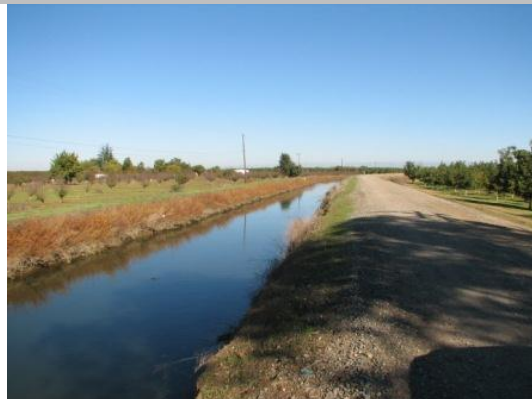
Photo 2 of 2 : FA\_2014\_MA0007\_200\_42\_20141110\_00008.jpg

Agricultural ditch landside slope and toe.

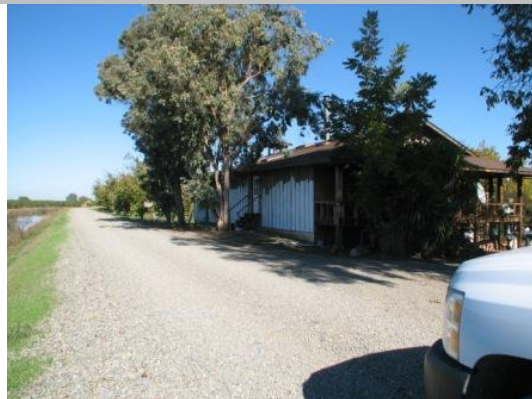
Photo 1 of 1 : FA\_2014\_MA0007\_200\_33\_20141110\_00004.jpg

LM Start	1.21	Rating **	U	Issue No.	33
LM End	1.21	Issue Type +	En	Location *	WS
Category	Earthen Levee			GPS Latitude/Longitude	
				Start	End
Item	Encroachments			39.327187 °	39.327187 °
				-121.632395 °	-121.632395 °
DWR ID	DWR_MA0007_01_s_2012_33				
Action/Comments					
Building

Levee mile 1.21. This is a photo of the building on the waterside slope.

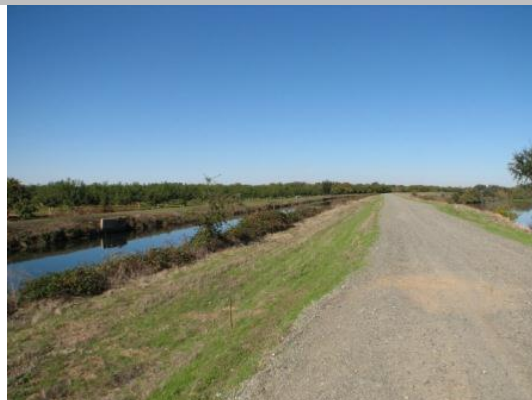
Photo 1 of 2 : FA\_2014\_MA0007\_200\_39\_20141110\_00005.jpg

LM Start	4.44	Rating **	M	Issue No.	39
LM End	5.37	Issue Type +	En	Location *	LS
Category	Earthen Levee			GPS Latitude/Longitude	
				Start	End
Item	Encroachments			39.366547 °	39.379262 °
				-121.647523 °	-121.650698 °
DWR ID	DWR_MA0007_01_s_2012_39				
Action/Comments					
Ditch

Ag ditch landside slope and toe.

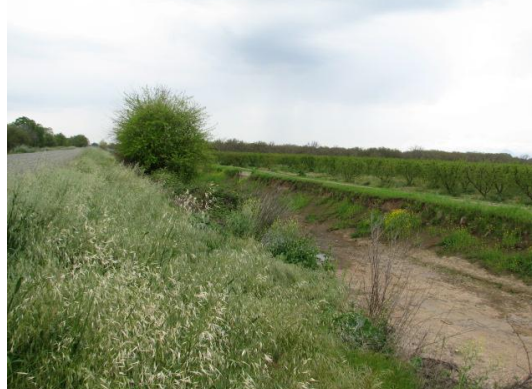
Photo 2 of 2 : FA\_2014\_MA0007\_200\_39\_20141110\_00006.jpg

Levee mile 5.37. This is a photo of the Ag ditch on the landside slope and toe.

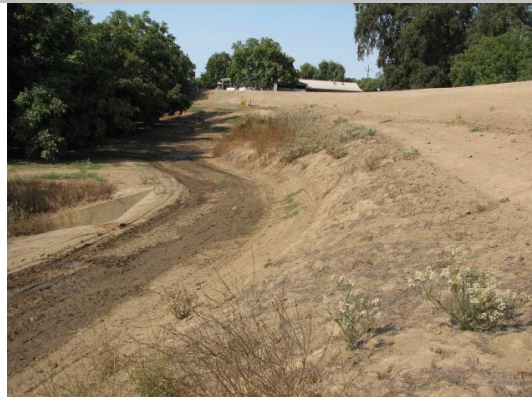
Photo 1 of 1 : FA\_2014\_MA0007\_200\_5\_20141110\_00001.jpg

LM Start	5.38	Rating **	M	Issue No.	5
LM End	5.98	Issue Type +	En	Location *	WS
Category	Earthen Levee			GPS Latitude/Longitude	
				Start	End
Item	Encroachments			39.380272 °	39.380527 °
				-121.649622 °	-121.638423 °
DWR ID	DWR_MA0007_01_f_2012_5				
Action/Comments					
Agricultural tilling Inspector Comments: This site is property of Cilker Revocable Trust, it has an encroachment violation notice dated 7-23-2012, enforcement action : 2011-321. The stockpile has been removed, excavation at the levee toe is still present.

This photo shows vehicle traffic has cut into the toe of the levee.

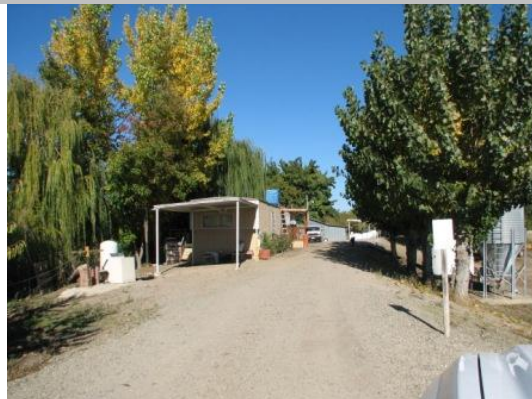
Photo 1 of 1 : FA\_2014\_MA0007\_200\_32\_20141110\_00003.jpg

LM Start	5.42	Rating **	U	Issue No.	32
LM End	5.42	Issue Type +	En	Location *	LS
Category	Earthen Levee			GPS Latitude/Longitude	
				Start	End
Item	Encroachments			39.379947 °	39.379947 °
				-121.650525 °	-121.650525 °
DWR ID	DWR_MA0007_01_s_2012_32				
Action/Comments					
Building

Levee mile 5.42. This photo shows a building on the landside crown, shoulder and slope.

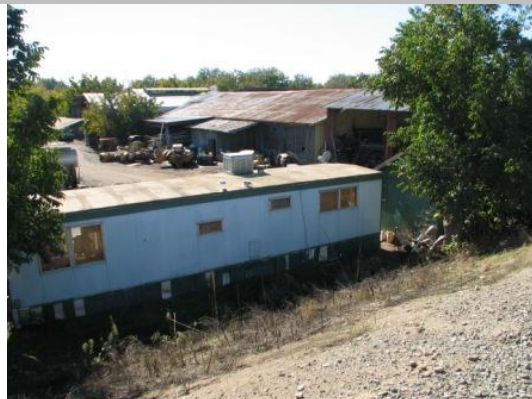
Photo 1 of 1 : FA\_2014\_MA0007\_200\_45\_20141110\_00010.jpg

LM Start	9.79	Rating **	U	Issue No.	45
LM End	9.79	Issue Type +	En	Location *	LS
Category	Earthen Levee			GPS Latitude/Longitude	
				Start	End
Item	Encroachments			39.416384 °	39.416384 °
				-121.634503 °	-121.634503 °
DWR ID	DWR_MA0007_01_s_2012_45				
Action/Comments					
Building

Levee mile 9.79. This photo shows a building at the landside toe.

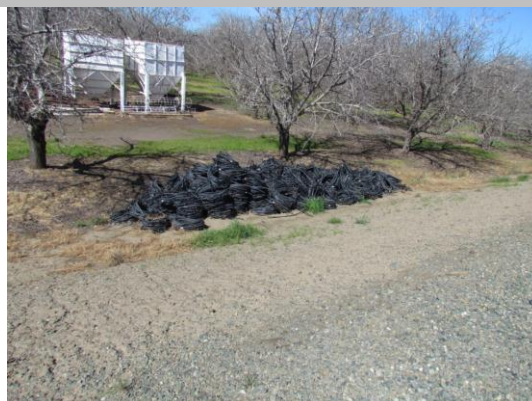
Photo 1 of 1 : FA\_2014\_MA0007\_200\_51\_20141110\_00011.jpg

LM Start	9.83	Rating **	M	Issue No.	51
LM End	9.83	Issue Type +	En	Location *	LS
Category	Earthen Levee			GPS Latitude/Longitude	
				Start	End
Item	Encroachments			39.416864 °	39.416864 °
				-121.634822 °	-121.634822 °
DWR ID	DWR_MA0007_01_s_2014_51				
Action/Comments					
Debris					
Inspector Comments: Irrigation pipe on landward levee slope. Spring 2014.

This photo was taken from the levee crown facing north looking at irrigation pipe placed on the levee slope near the landward toe. Spring 2014.

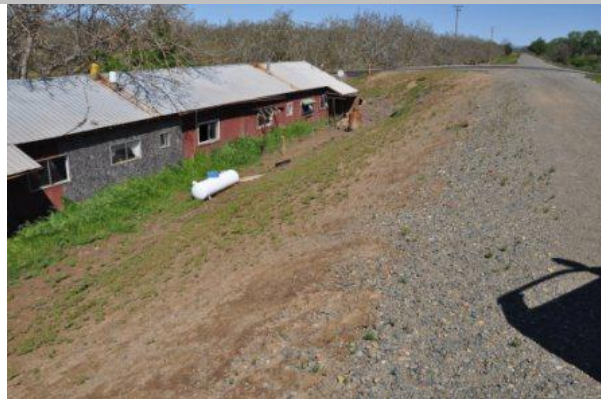
Photo 1 of 1 : FA\_2014\_MA0007\_200\_15\_20141110\_00002.jpg

LM Start	11.24	Rating **	M	Issue No.	15
LM End	11.24	Issue Type +	En	Location *	LS
Category	Earthen Levee			GPS Latitude/Longitude	
				Start	End
Item	Encroachments			39.431591 °	39.431591 °
				-121.645477 °	-121.645477 °
DWR ID	DWR_MA0007_01_s_2013_15				
Action/Comments					
Building Inspector Comments: Building appears to be abandoned.

L/S levee toe- Abandoned building.

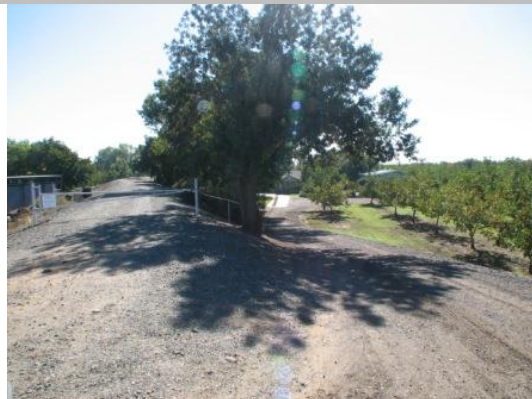
Photo 1 of 1 : FA\_2014\_MA0007\_200\_43\_20141110\_00009.jpg

LM Start	11.63	Rating **	M	Issue No.	43
LM End	11.69	Issue Type +	En	Location *	LS
Category	Earthen Levee			GPS Latitude/Longitude	
				Start	End
Item	Vegetation			39.437119 °	39.437949 °
				-121.645860 °	-121.646280 °
DWR ID	DWR_MA0007_01_s_2012_43				
Action/Comments					
Landscaping

Landside landscaping levee mile 11.63.
